# ***Comparative study of two buildings which covered by Zsolnay ceramics, in aspect of deterioration by environmental factors***

**Meeting of Young Geoscientists  
March 28-29, 2014, Balatonföldvár**

# Buildings and materials

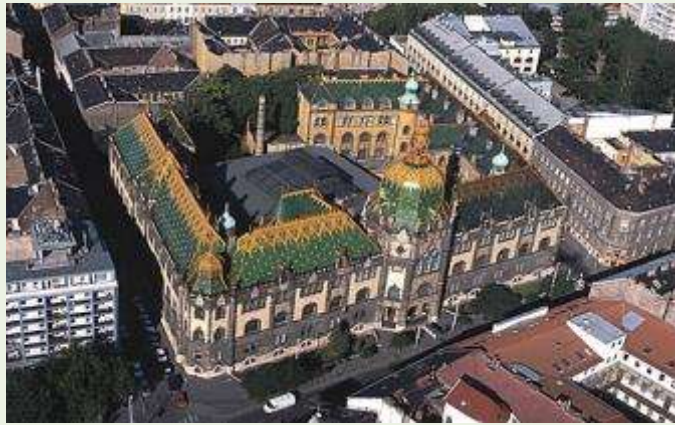
## Museum of Applied Arts

(center of the city, high traffic rate)

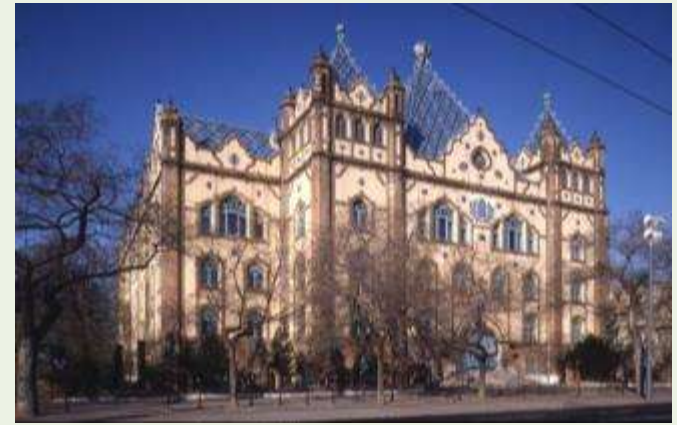
## Geological and Geophysical Institute of Hungary

(city quarter with moderate traffic)

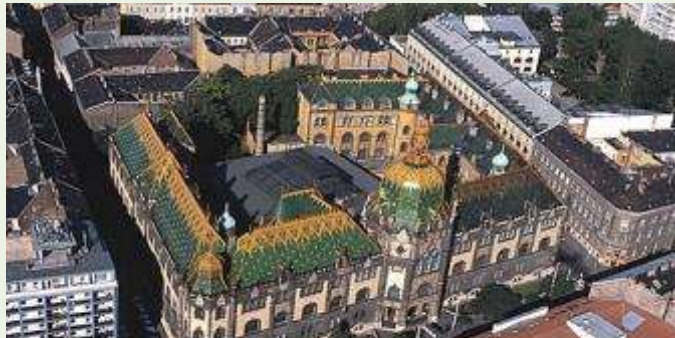
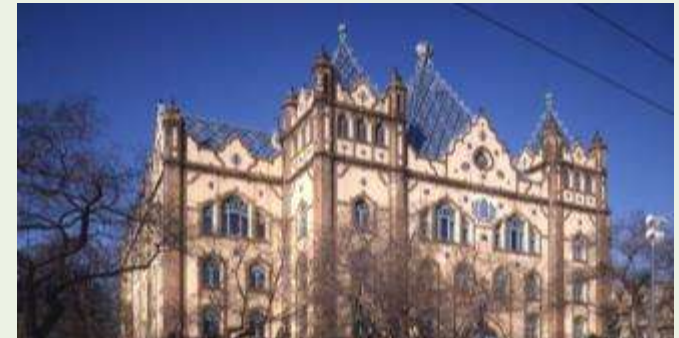
Red dots  
indicate the  
sampling sites  
of the roof

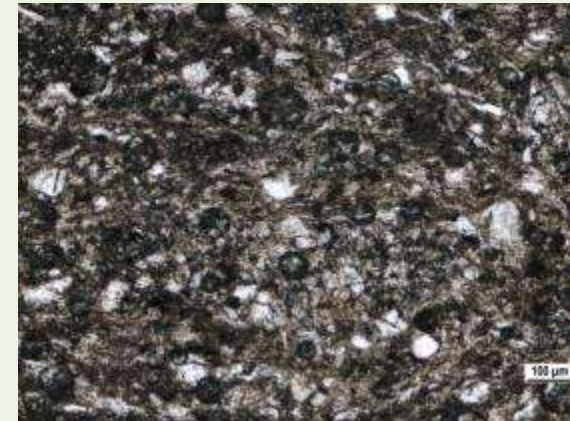
### 3. group = **the youngest ceramics**

texture = **serial**

- Mostly glassy matrix
- Weakly inhomogeneity
- Quartz(fine grained)  
→ ~ 15%
- Well classified
- More argillaceous particles
- Pores

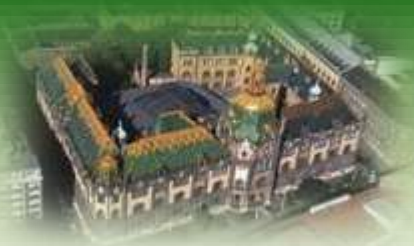
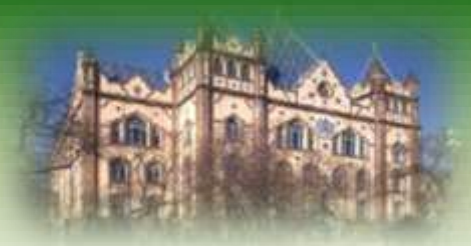
Deposition layer: the thickness of this layer is variable between 10-50  $\mu\text{m}$ .  
Consist of dust, soot and aerosols in variable quantity.

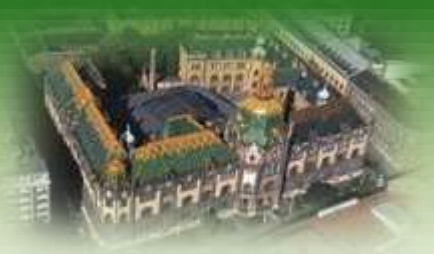
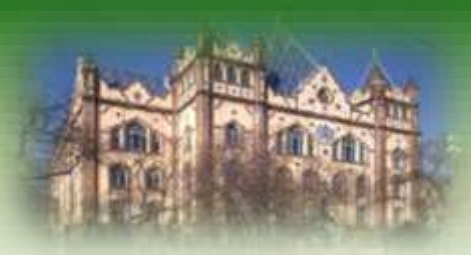
It is also observed that this contamination layer firmly adheres to the surface but some cases cracks and fragments from it and rarely penetrates below the cracked glaze layer.

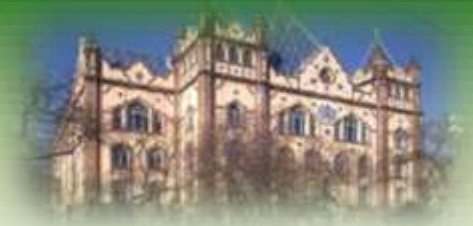
- Yellow and green lead-glaze
- Thickness  $\sim 180\text{-}300\ \mu\text{m}$
- Colored by iron (yellow) and copper (green)
